# IDENTIFICATION OF CHARACTER AND INTENSITY OF WEAR OF PVD COATED TWIST DRILLS IN DRILLING OF C 45 MATERIAL

MARIAN HARSANI, MATEJ MIKLOS, IVAN MORGOS

STATON, s.r.o., Turany, Slovakia

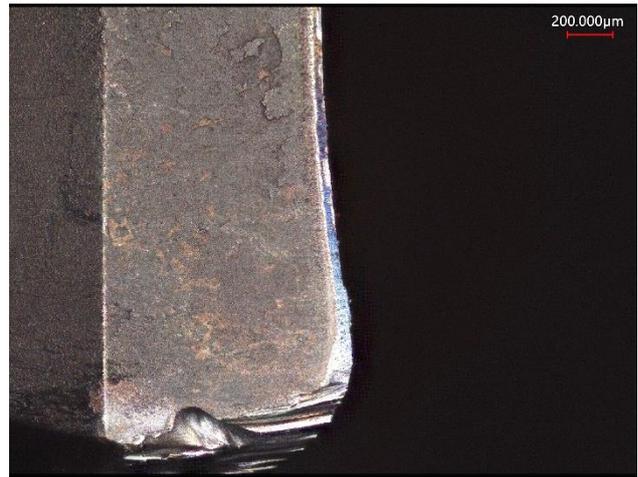
**Figure 5.** Flank wear of drill with AlTiCrN (No. 1) after 3104 drilled holes, mag. x5.

Along the whole cutting edge, the flank of drills exhibited a diffusive mechanism of wear with adhered material, characterized like built-up edge (BUE). The diffusive wear indicates that the tool material is diffusing into the chip as a result of very high temperatures on the tool-chip interface. Due to high temperature, pressure and friction on this interface, the layer of coating disrupted, and thus, a pure metal contact of the machined and cutting material occurs. Therefore, BUE was observed at the spots of diffusion wear (Fig. 6) and in this case, it can be considered as a consequence of the action of an adhesive mechanism of wear.

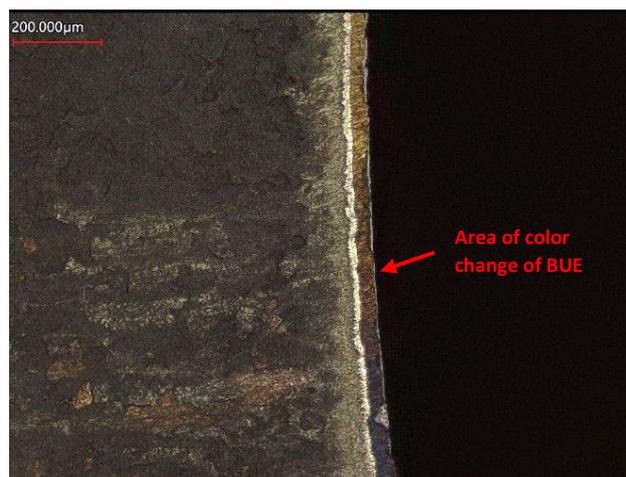
**Figure 8.** Color change of BUE at middle area of flank on drill with AlTiCrN (No. 2) after 3104 drilled holes, mag. x10.

The change of color of the BUE on drilling tools with the AlTiCrN coating was detected approximately in middle area of the cutting edge (Fig. 8). Based on this, change in the process temperature can be expected in this area. Since the aim of this work was not to monitor the change in temperature along the cutting edge during drilling, we can only assume in which range of temperatures was moving. It is assumed that the yellow-colored chip and also the BUE have been affected by lower process temperatures. However, this cannot be said with certainty without a specifically focused experimental

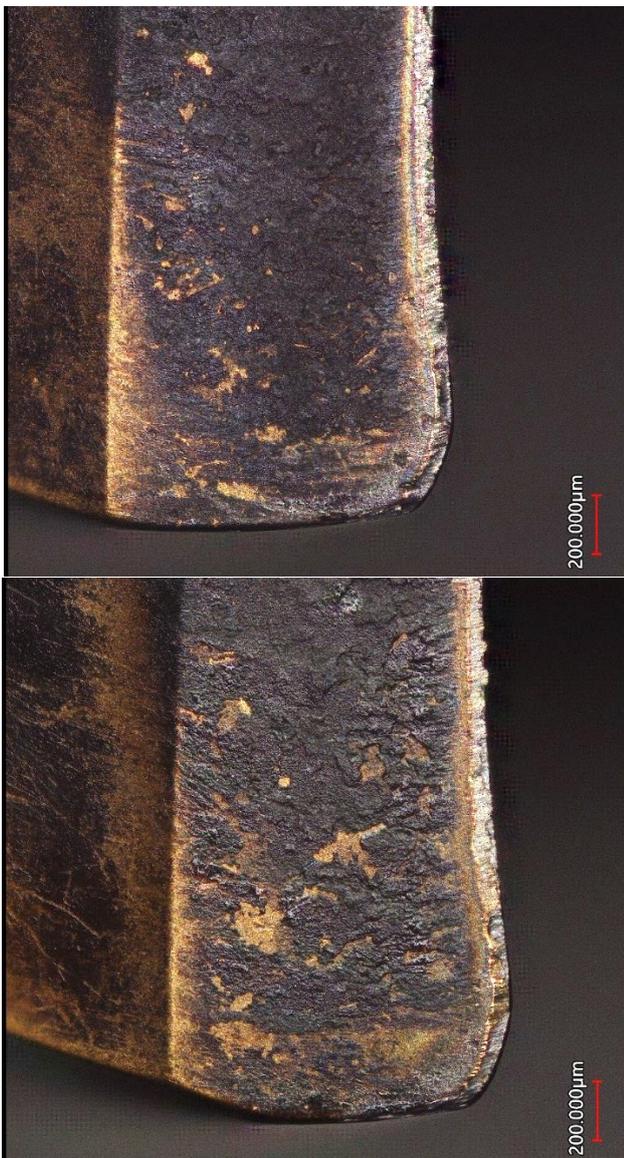
**Figure 12.** Flank wear of drill with PVD coating TiSiN (No. 1) after 3104 drilled holes, mag. x5

The  $VB_{C_{max}}$  on the flank of drill with TiSiN coating (Fig. 12) was significantly lower than both observed AlTiCrN and AlTiSiN coatings after criterion of wear (almost 4 times smaller than AlTiCrN, and about 2 times smaller than AlTiSiN). The absolute increase in  $VB_{C_{max}}$  from 1904 to 3104 drilled holes was 163 µm, which is a much less steep increase than was at AlTiCrN and AlTiSiN coatings. The dominant wear mechanism along the cutting edge is diffusive-adhesive mechanism again. The wear at outer corner of drill had also abrasive character with the range of diffusive wear substantially smaller on the corner of drill, what we can see in Fig. 13. At the corner of the drill with TiSiN coating, it was observed a low amount of yellow colored BUE. Deep purple color of BUE was not observed at any drills with TiSiN coating, and therefore, it can be assumed that the total temperature during drilling was again significantly reduced and lower than in the case of AlTiCrN and AlTiSiN coatings. With less occurrence of BUE, the process fluid penetrates into cutting area

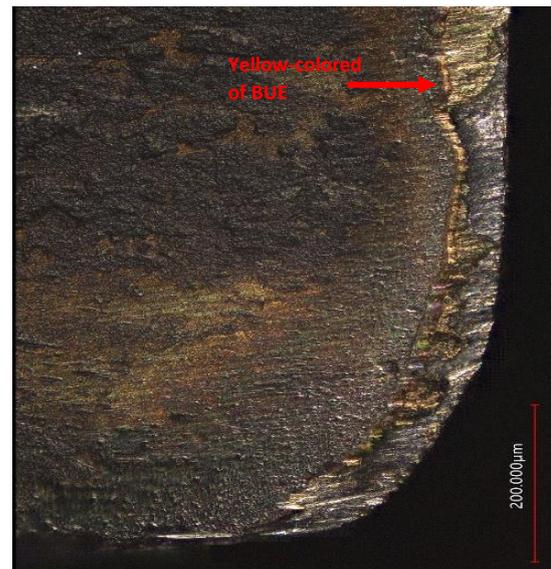
**Figure 13.** Detail of flank wear on the corner of the drill with PVD coating TiSiN (No. 2) after 3104 drilled holes, mag. x20

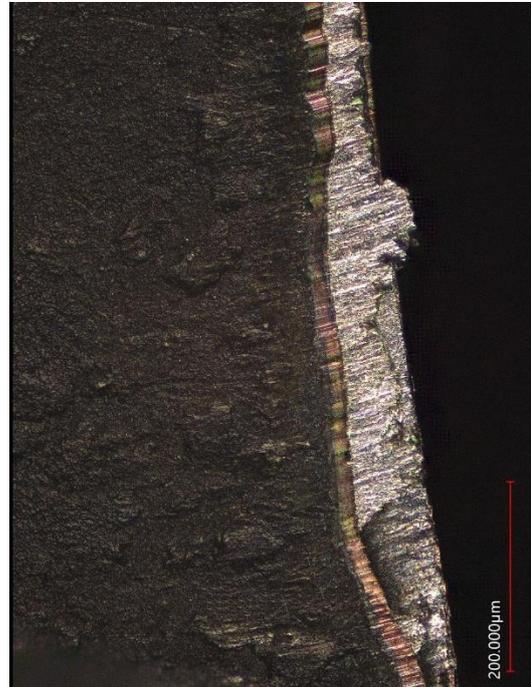
**Figure 16.** Detail of BUE on the flank of drill at  $\frac{1}{4}$ area. Coating AlTiSiN (No. 1) after 3104 drilled holes, mag. x20.

The paradox for the TiAlSiN coating was that the area of the  $VB_{Bmax}$  showed the highest flank wear among the studied drills. Compared to AlTiCrN, average  $VB_{Bmax}$  wear is almost 78 % greater (Fig. 4). Both at the outer corner of the drill and at this area, the BUE color was white with variable height (Fig. 16).
